# St Marys Churchyard, Abbots Ann

Health and Safety Tree Survey walk over on  
behalf of Abbots Ann Parish Council  
12th September 2025

St Marys Churchyard, Abbots Ann - Walk over Tree survey September 2025

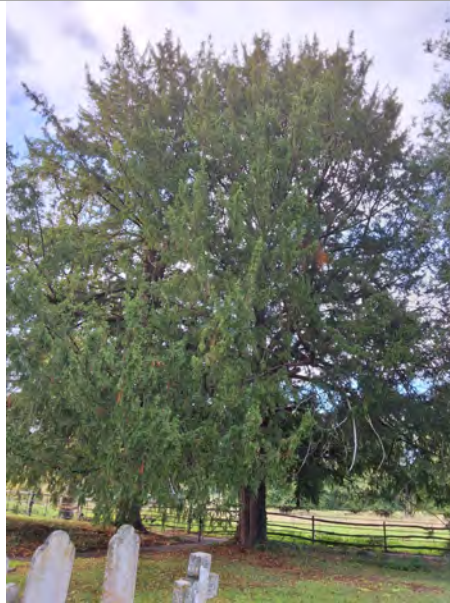
000936	16	Taxus baccata (Common Yew)	Churchyard of St Mary's Church by gate and public footpath	51.190632, -1.528077	/// shack.clock.arrows	1	1	14	111	Mature	Normal	Good	<ul style="list-style-type: none"><li>Conservation area (CA)</li><li>Fence within falling distance</li><li>Footpath within falling distance</li><li>Footpath under canopy</li><li>Gravestones</li><li>Grass surround</li></ul>	<ul style="list-style-type: none"><li>Branch stubs present</li><li>Crown shape distorted due to group pressure</li><li>Epicormic growth</li><li>General observations - This is a Veteran Yew tree around 260 - 340 years of age. Yews are one of the longest-lived native trees and are ecologically valuable as well as historically, culturally and environmentally. They are associated with immortality and the ability of the species to renew itself and they are evergreen. Yew is symbolic of everlasting life and rebirth as well as death and resurrection.</li><li>Ivy or climbing plants</li><li>Low hanging branches</li><li>Major dead wood &gt;50mm</li><li>Minor dead wood &lt;50mm</li></ul>	<ul style="list-style-type: none"><li>Remove dead wood (&gt;50mm ) - for reasons of health and safety</li><li>Lift canopy to 2.5m</li><li>Reduce branch - reduce the lowest limb over the churchyard by 3 metres to remove the obpverhang of the grave stones.</li></ul>	Priority within 3 months for reasons of health and safety.

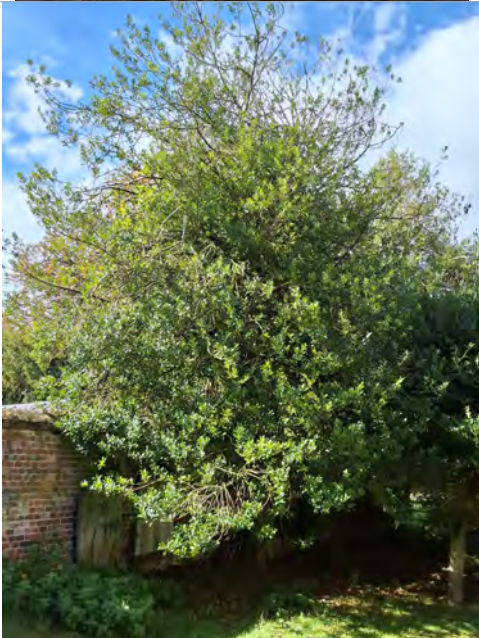
006618	4	Ilex aquifolium (Common Holly)	Churchyard of St Mary's Church	51.190424, -1.528901	/// land.chains.equal	1	1	6	43	Middle aged	Low	Fair	· Churchyard · Gravestones · Grass surround · Historic or listed building or wall	· Basal suckers · Die back - Apical decline · Low hanging branches	· Prune back or clear from building - prune back from the wall and lift over the wall to achieve 0.5 metres above the wall.  · Lift canopy to 2.5m  · Removal basal growth	Routine within 12 months	
006619	5	Buxus sempervirens (Box)	Churchyard of St Mary's Church	51.190478, -1.528835	/// record.mime.page	1	1	6	20	Middle aged	Normal	Fair	· Churchyard · Gravestones · Grass surround	· Crossing branches · Diseased - Box blight · Low hanging branches	· Lift canopy to 2.5m	Routine within 12 months	
000933	6	Taxus baccata "Fastigiata" (Irish Yew)	Churchyard of St Mary's Church by the Priest's door	51.190445, -1.528786	/// chief.discrepancy.stacks	1	1	4	65	Middle aged	Normal	Good	· Building within falling distance - St Mary's Church · Churchyard · Conservation area (CA) · Footpath within falling distance · Footpath under canopy · Gravestones · Grass surround · Overhead services - lights in tree and overhead cable above tree	· Bark damage - from wire cutting into branches · Crown issues or observations - Branches collapsed out of the crown and are hanging down. Fastigate form opening up. Previously supported by wire which in places is now imbedded wire cables which are now causing bark and branch damage. · Epicormic growth	· Reduce branch - Prune in the branches the are falling out of the crown all round. Trim up the sides to maintain the compact form. (Routine)	Routine within 12 months

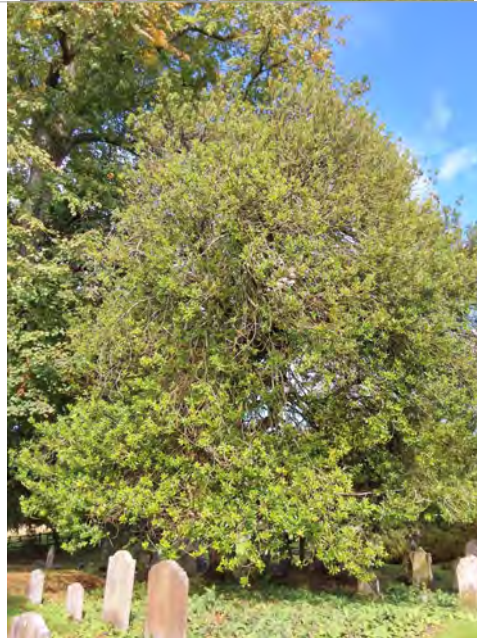
006628	17	Ilex aquifolium (Common Holly)	Churchyard of St Mary's Church	51.190437, -1.528111	/// horn.skins.shunts	1	1	11	50	Mature	Low	Fair	<ul style="list-style-type: none"><li>Churchyard</li><li>Gravestones</li><li>Grass surround</li><li>Historic or listed building or wall</li></ul>	<ul style="list-style-type: none"><li>Basal suckers</li><li>Low hanging branches</li></ul>	<ul style="list-style-type: none"><li>Lift canopy to 2.5m</li></ul>	Routine within 12 months
000934	18	Ilex aquifolium (Common Holly)	Churchyard of St Mary's Church	51.190464, -1.528018	/// impact.vocab.month	3	1	7.8	53	Middle aged	Low	Fair	<ul style="list-style-type: none"><li>Conservation area (CA)</li><li>Footpath within falling distance</li><li>Gravestones</li><li>Grass surround</li></ul>	<ul style="list-style-type: none"><li>Basal suckers</li><li>Crown reduced - dead stems previously removed</li><li>Crown shape distorted due to group pressure</li><li>Die back</li><li>Epicormic growth</li><li>Ivy or climbing plants</li><li>Minor dead wood &lt;50mm</li><li>Trifurcated - just above ground level, one stem healthy, remaining two stems in decline</li></ul>	<ul style="list-style-type: none"><li>Lift canopy to 3m</li></ul>	Routine within 12 months

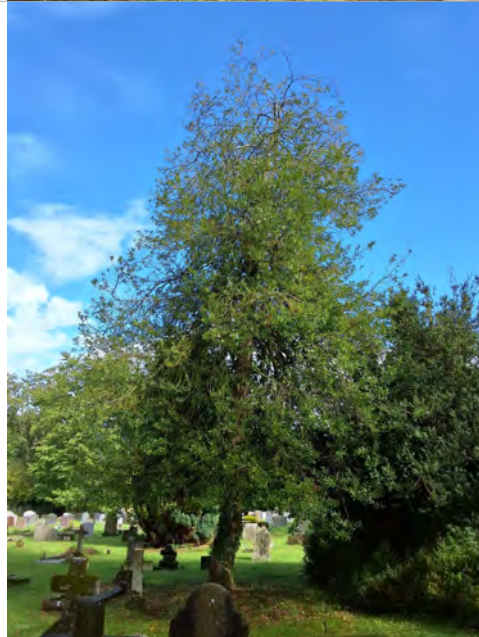
006629	19	Ilex aquifolium (Common Holly)	Churchyard of St Mary's Church	51.190537, -1.527965	/// points.toys.taker	1	1	5	42	Middle aged	Low	Fair	<ul style="list-style-type: none"><li>Churchyard</li><li>Gravestones</li><li>Grass surround</li></ul>	<ul style="list-style-type: none"><li>Die back</li><li>Ivy or climbing plants</li></ul>	<ul style="list-style-type: none"><li>Sever climbing plant and remove 1st 2 metres from trunk</li><li>Lift canopy to 2.5m</li></ul>	Routine within 12 months
006630	20	Taxus baccata (Common Yew)	Churchyard of St Mary's Church	51.190327, -1.528112	/// voice.giant.waving	2	1	12	60	Middle aged	Normal	Good	<ul style="list-style-type: none"><li>Churchyard</li><li>Gravestones</li><li>Grass surround</li><li>Historic or listed building or wall</li></ul>	<ul style="list-style-type: none"><li>Bifurcated</li><li>Ivy or climbing plants</li><li>Low hanging branches</li></ul>	<ul style="list-style-type: none"><li>Sever climbing plant and remove 1st 2 metres from trunk</li><li>Prune back or clear from building - prune back from the wall and lift over the wall to achieve 0.5 metres above the wall.</li><li>Lift canopy to 2.5m</li></ul>	Routine within 12 months

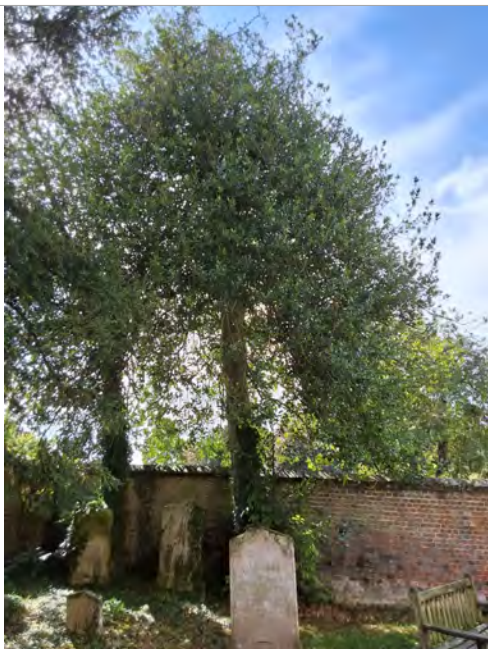
006620	7	Ilex aquifolium (Common Holly)	Churchyard of St Mary's Church	51.190377, -1.528866	/// video.tiles.opposite	1	1	4	45	Middle aged	Normal	Fair	· Churchyard · Gravestones · Grass surround · Historic or listed building or wall	· Basal suckers · Crown shape distorted due to group pressure · Ivy or climbing plants · Low hanging branches	· Sever climbing plant and remove 1st 2 metres from trunk  · Prune back or clear from building - prune back from the wall and lift over the wall to achieve 0.5 metres above the wall.  · Lift canopy to 2.5m  · Removal basal growth	Routine within 12 months	
006621	8	Ilex aquifolium (Common Holly)	Churchyard of St Mary's Church	51.190352, -1.528859	/// blur.chefs.entertainer	1	1	4	30	Middle aged	Low	Fair	· Churchyard · Gravestones · Grass surround · Historic or listed building or wall	· Bifurcated · Ivy or climbing plants · Low hanging branches · Unable to fully assess due to ivy	· Prune back or clear from building - prune back from the wall and lift over the wall to achieve 0.5 metres above the wall.  · Sever and remove ivy up to 1.5m  · Lift canopy to 2.5m	Routine within 12 months

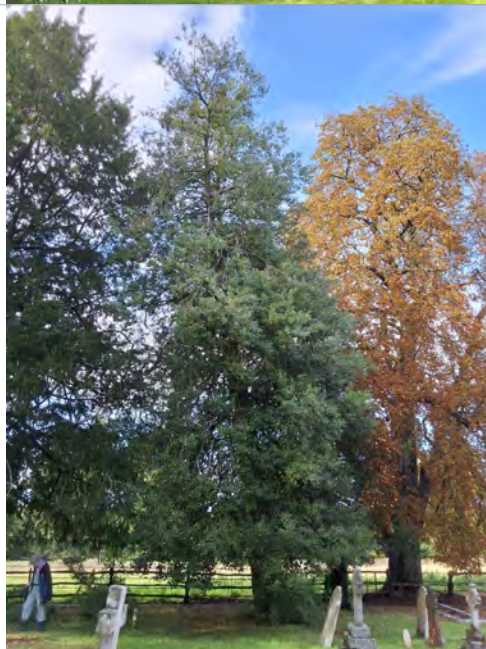
006631	21	Ilex aquifolium (Common Holly)	Churchyard of St Mary's Church	51.190666, -1.527948	/// modern.send.knee	2	1	9	40	Middle aged	Normal	Fair	<ul style="list-style-type: none"><li>Churchyard</li><li>Footpath within falling distance</li><li>Gravestones</li><li>Grass surround</li></ul>	<ul style="list-style-type: none"><li>Crown shape distorted due to group pressure</li><li>Ivy or climbing plants</li><li>Low hanging branches</li></ul>	<ul style="list-style-type: none"><li>Sever climbing plant and remove 1st 2 metres from trunk</li><li>Lift canopy to 2.5m</li></ul>	Routine within 12 months
006632	22	Ilex aquifolium (Common Holly)	Churchyard of St Mary's Church	51.190701, -1.527879	/// myself.them.author	3	1	9	30	Middle aged	Normal	Fair	<ul style="list-style-type: none"><li>Churchyard</li><li>Footpath within falling distance</li><li>Footpath under canopy</li><li>Gravestones</li><li>Grass surround</li><li>Public footpath</li></ul>	<ul style="list-style-type: none"><li>Basal suckers</li><li>Crown shape distorted due to group pressure</li><li>Ivy or climbing plants</li><li>Trifurcated - one stem previously removed</li></ul>	<ul style="list-style-type: none"><li>Sever and remove ivy up to 1.5m</li><li>Lift canopy to 2.5m</li><li>Removal basal growth</li></ul>	Routine within 12 months

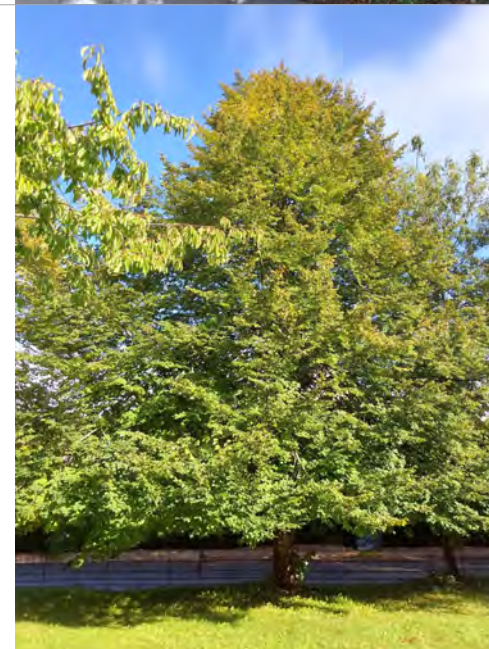
006645	36	Tilia cordata (Small-leaved Lime)	Churchyard of St Mary's Church	51.190590, -1.527028	/// sound.shaped.excuse	1	1	13	54	Young	Normal	Good	· Churchyard · Fence within falling distance · Fence under canopy · Grass surround · Road within falling distance	· Basal suckers · Epicormic growth · Low hanging branches	· Lift canopy to 3m - over churchyard · Lift canopy to 5m - over road	Priority within 3 months for reasons of health and safety.
006646	37	Tilia cordata (Small-leaved Lime)	Churchyard of St Mary's Church	51.190688, -1.527038	/// take.odds.camp	1	1	13	67	Middle aged	Normal	Good	· Bench · Churchyard · Footpath within falling distance · Grass surround · Parking within falling distance · Road under canopy · Road within falling distance	· Basal suckers · Hanging broken branches - small ones roadside · Low hanging branches · Minor dead wood <50mm · Stem issues or observations - stake embedded in trunk	· Lift canopy to 3m - over churchyard · Lift canopy to 5m - over roadside	Priority within 3 months for reasons of health and safety.

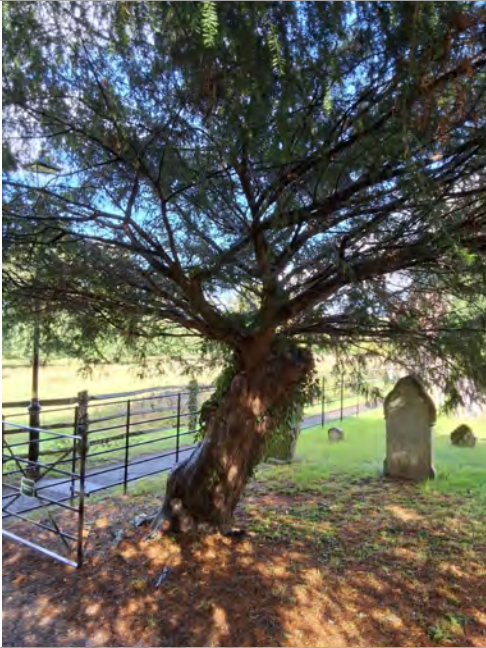
006622	9	Taxus baccata (Common Yew)	Churchyard of St Mary's Church	51.190571, -1.528782	/// feeds.loss.future	1	1	7	69	Middle aged	Low	Fair	· Churchyard · Fence within falling distance · Footpath within falling distance · Footpath under canopy · Fence under canopy · Grass surround · Street lamp	· Crown reduced - topped historically after if fell · Ivy or climbing plants · Low hanging branches · Stunted	· Lift canopy to 2.5m  · Prune clear of street Lamp	Routine within 12 months	
006623	10	Taxus baccata "Fastigiata" (Irish Yew)	Churchyard of St Mary's Church	51.190545, -1.528777	/// pulled.nerve.shakes	1	1	3	70	Middle aged	Low	Fair	· Churchyard · Footpath within falling distance · Grass surround	· Crown issues or observations - wire holding in branches	· Hedge pruning maintenance - trim all round and reduce down by 2 metres to improve lower density.	Routine within 12 months

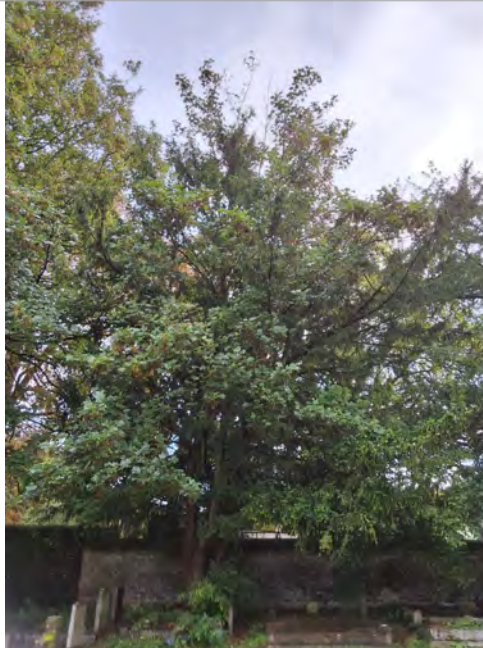
006634	24	Taxus baccata (Common Yew)	Churchyard of St Mary's Church	51.190332, -1.527945	/// joins.cigar.stuck	4	1	9	80	Middle aged	Normal	Fair	<ul style="list-style-type: none"><li>Churchyard</li><li>Grass surround</li><li>Historic or listed building or wall</li></ul>	<ul style="list-style-type: none"><li>Low hanging branches</li><li>Multi stemmed - Sycamore growing in the trunk fused I tothe main stem</li></ul>	<ul style="list-style-type: none"><li>Prune back or clear from building - prune back from the wall and lift over the wall to achieve 0.5 metres above the wall.</li><li>Lift canopy to 2.5m</li><li>Remove stem - Remove the Sycamore stem by cutting it down to 2 metres.</li></ul>	Routine within 12 months

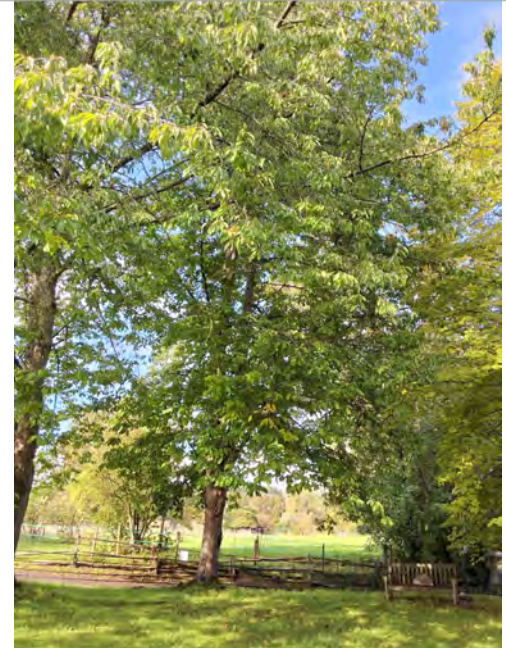
006647	38	Prunus cerasifera (Cherry Plum)	Churchyard of St Mary's Church	51.190716, -1.527165	///post.logs.serve	1	1	12	50	Middle aged	Normal	Good	· Bench · Churchyard · Footpath within falling distance · Footpath under canopy · Grass surround	· Bifurcated · Crown shape distorted due to group pressure · Exposed roots / damaged roots · Girdling roots · Low hanging branches · Major dead wood >50mm · Mower or strimmer damage	· Remove dead wood (>50mm ) · Lift canopy to 3m	Priority within 3 months for reasons of health and safety.
006648	39	Prunus cerasifera (Cherry Plum)	Churchyard of St Mary's Church	51.190695, -1.527252	/// aside.dance.chip	1	1	20	67	Middle aged	Normal	Good	· Churchyard · Footpath within falling distance · Footpath under canopy · Gravestones · Grass surround · Public footpath	· Branch stubs present · Exposed roots / damaged roots · Low hanging branches · Minor dead wood <50mm · Mower or strimmer damage · Narrow or tight forks	· Lift canopy to 3m	Routine within 12 months

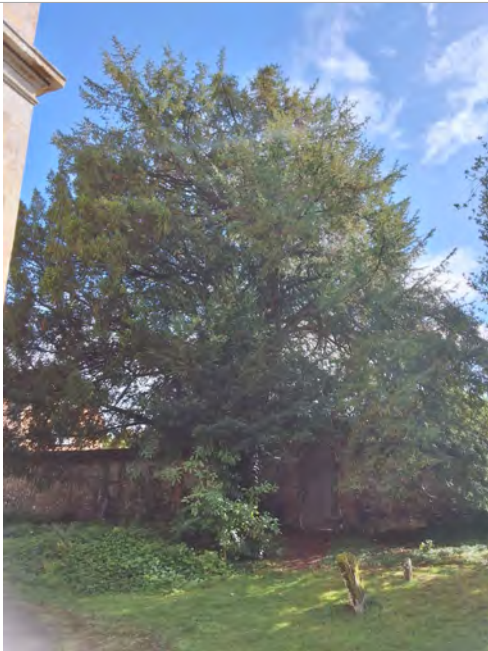
006624	11	Taxus baccata (Common Yew)	Churchyard of St Mary's Church	51.190353, -1.528748	/// loud.rush.galaxy	1	1	6	60	Middle aged	Normal	Fair	<div>· Churchyard</div> <div>· Grass surround</div> <div>· Historic or listed building or wall</div>	<div>· Crown shape distorted due to group pressure</div> <div>· Ivy or climbing plants</div> <div>· Low hanging branches</div>	<div>· Sever climbing plant and remove 1st 2 metres from trunk</div> <div>· Prune back or clear from building - prune back from the wall and lift over the wall to achieve 0.5 metres above the wall.</div> <div>· Lift canopy to 2.5m</div>	Routine within 12 months
006625	12	Taxus baccata (Common Yew)	Churchyard of St Mary's Church	51.190343, -1.528724	/// loud.rush.galaxy	1	1	8	60	Middle aged	Normal	Good	<div>· Churchyard</div> <div>· Grass surround</div> <div>· Historic or listed building or wall</div>	<div>· Crown shape distorted due to group pressure</div> <div>· Ivy or climbing plants</div> <div>· Low hanging branches</div>	<div>· Sever climbing plant and remove 1st 2 metres from trunk</div> <div>· Prune back or clear from building - prune back from the wall and lift over the wall to achieve 0.5 metres above the wall.</div> <div>· Lift canopy to 2.5m</div>	Routine within 12 months

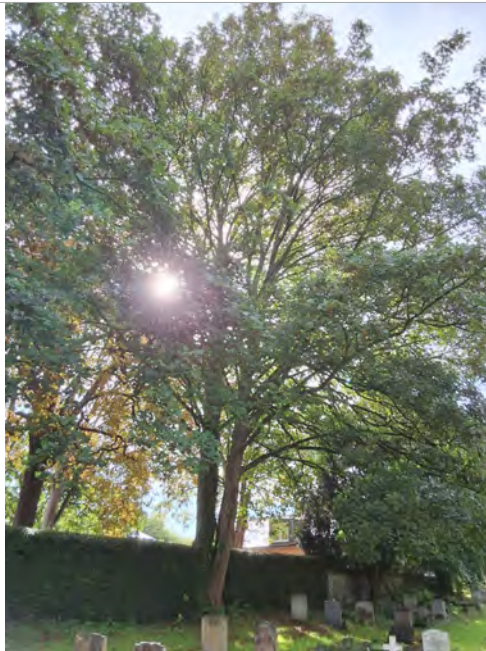
006635	25	Acer pseudoplatanus (Sycamore)	Churchyard of St Mary's Church	51.190325, -1.527770	/// social.about.ties	4	1	20	55	Mature	Normal	Good	· Churchyard · Gravestones · Grass surround	· Ivy or climbing plants · Low hanging branches · Multi stemmed · Multiple old pruning wounds	· Lift canopy to 2.5m	Routine within 12 months
006636	26	Quercus robur (English Oak)	Churchyard of St Mary's Church	51.190327, -1.527537	/// stove.solid.smile d	1	1	6	12	Young	Normal	Fair	· Grass surround · Memorial tree - Planted by the WI in 2000	· Crown shape distorted due to group pressure · Developing young tree · Epicormic growth	None currently required.	No tree work required
006637	27	Chamaecyparis sp. (Cypress spp)	Churchyard of St Mary's Church	51.190414, -1.527777	/// method.loveing.o pens	10	1	5	20	Over mature	Low	Poor	· Churchyard · Gravestones · Grass surround	· Die back - browning foliage, collapsing branches, reached maturity · Multi stemmed	· Fell Conifers	Routine within 12 months

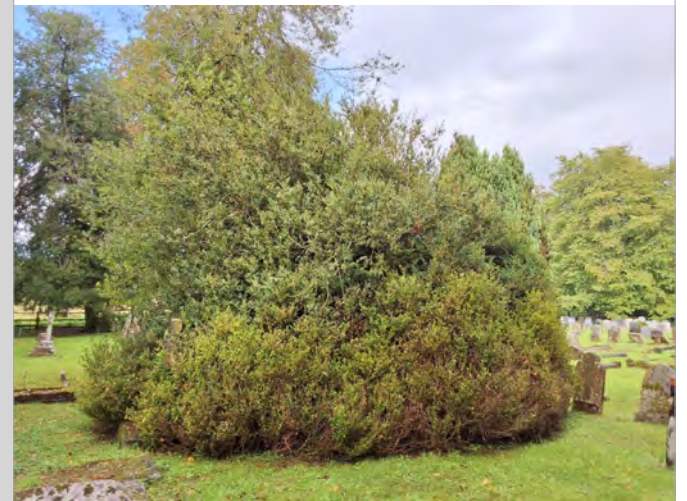
006650	40	Buxus sempervirens (Box)	Churchyard of St Mary's Church	51.190492, -1.527919	/// invent.prep.dices	1	1	6	15	Middle aged	Low	Fair	· Churchyard · Gravestones · Grass surround	· Die back · Diseased - Box blight · Ivy or climbing plants · Multi stemmed	None currently required.	No tree work required

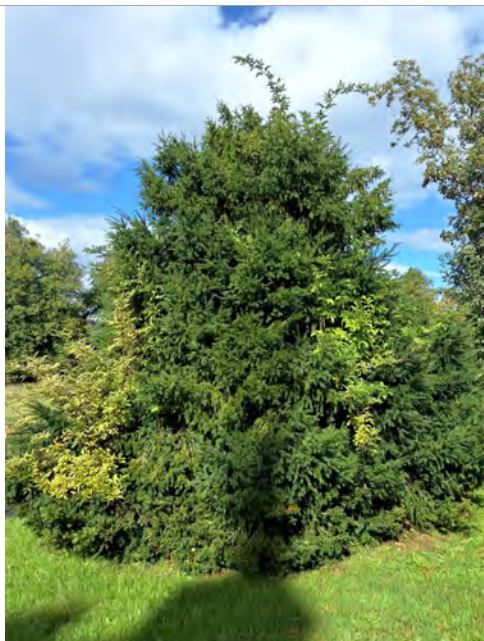
006626	13	Taxus baccata (Common Yew)	Churchyard of St Mary's Church	51.190608, -1.528448	/// vase.react.joins	1	1	5	40	Middle aged	Normal	Good	<div>· Churchyard</div> <div>· Grass surround</div>	<div>· Low hanging branches</div>	<div>· Hedge pruning maintenance - clip to prune back from the path</div>	Routine within 12 months
000932	14	Tilia x europaea (Common Lime)	Adjacent to the Churchyard of St Mary's Church	51.190467, -1.528221	/// cape.games.crazy	1	1	13	133	Mature	Normal	Good	<div>· Building within falling distance - St Mary's Church</div> <div>· Conservation area (CA)</div> <div>· Footpath within falling distance</div> <div>· Footpath under canopy</div> <div>· Gravestones</div> <div>· Grass surround</div>	<div>· Bat potential</div> <div>· Basal suckers</div> <div>· Cavities present</div> <div>· Epicormic growth</div> <div>· Fluted buttresses</div> <div>· General observations - Veteran tree characteristics include a large girth minimum of 25% of species age equating to around 140-170 years of age circa 1850's. With potential for internal heartwood decay, large quantities of deadwood, habitat holes and epiphytic plants including lichens. This is an important tree locally as well as historically, culturally, ecologically and environmentally.</div> <div>· Ivy or climbing plants - starting up the trunk and around the buttresses</div> <div>· Live epicormic growth rafting</div> <div>· Major dead wood &gt;50mm</div> <div>· Minor dead wood &lt;50mm</div> <div>· Multiple old pruning wounds</div> <div>· Occluded pruning wounds</div> <div>· Occluding pruning wounds</div> <div>· Surface roots - lifting tarmac path and visible in the grass bank, bark damage to some exposed roots and decay present</div>	<div>· Remove dead wood (&gt;50mm ) - within 1 month for reasons of health and safety</div> <div>· Lift canopy to 3m - over the footpath and graves within 3 months for reasons of health and safety</div>	High priority within 1 month for reasons of health and safety.
