# St Marys Churchyard, Abbots Ann

Health and Safety Tree Survey walk over on  
behalf of Abbots Ann Parish Council  
12th September 2025

St Marys Churchyard, Abbots Ann - Walk over Tree survey September 2025

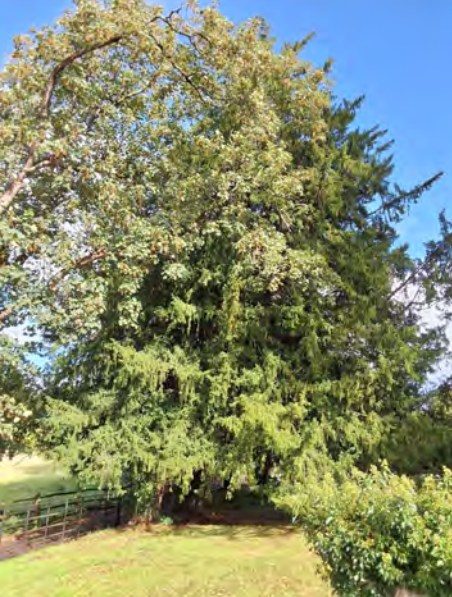
006627	15	Taxus baccata (Common Yew)	Churchyard of St Mary's Church	51.190631, -1.528192	/// bike.owners.divide	1	1	14	78	Middle aged	Normal	Good	<div>· Churchyard</div> <div>· Footpath within falling distance</div> <div>· Footpath under canopy</div> <div>· Gravestones</div> <div>· Grass surround</div> <div>· Public footpath</div>	<div>· Crown shape distorted due to group pressure</div> <div>· Epicormic growth</div> <div>· Exposed roots / damaged roots</div> <div>· Ivy or climbing plants</div> <div>· Low hanging branches</div> <div>· Mower or strimmer damage</div>	<div>· Lift canopy to 2.5m</div>	Routine within 12 months
